## FIRST FIVE YEAR REVIEW REPORT

### KENNECOTT SOUTH ZONE

OU 1 Bingham Creek  
OU 4 Large Bingham Reservoir  
OU 5 Copperton Tailings  
OU 10 Copperton Soils  
OU 11 Bingham Canyon  
OU17 Bastian Sink

June, 2004

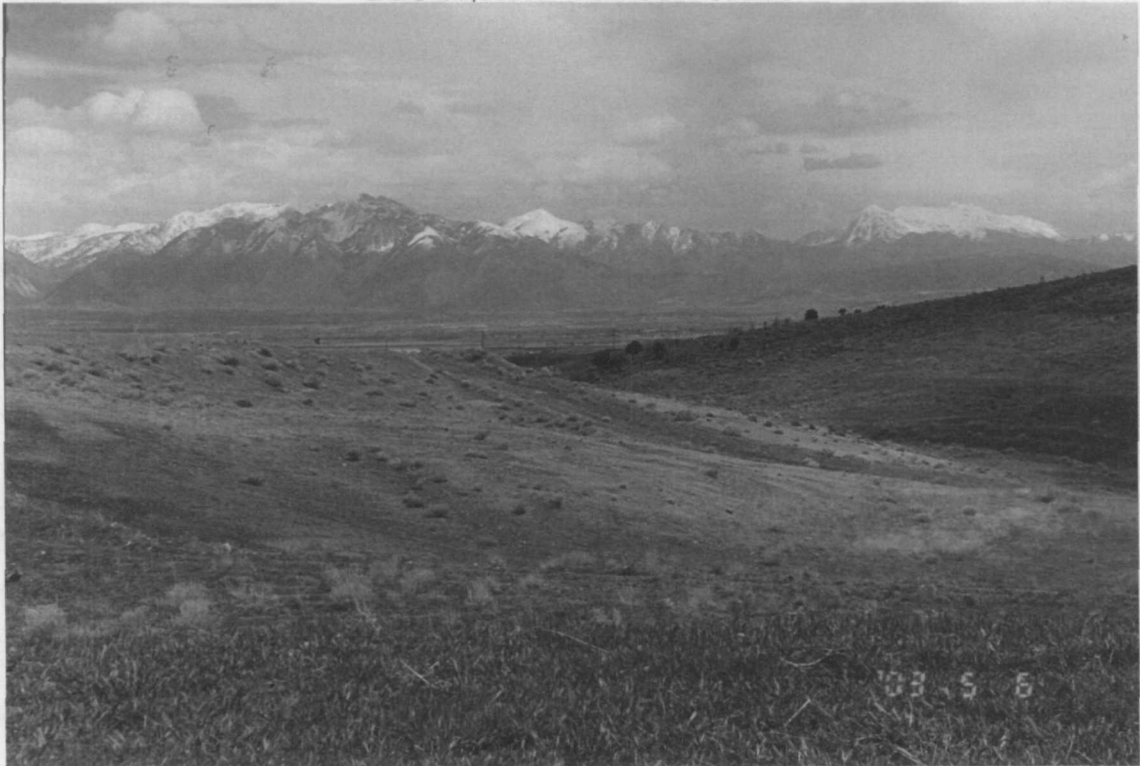
Open Bluewater Repository with closed portion in foreground.

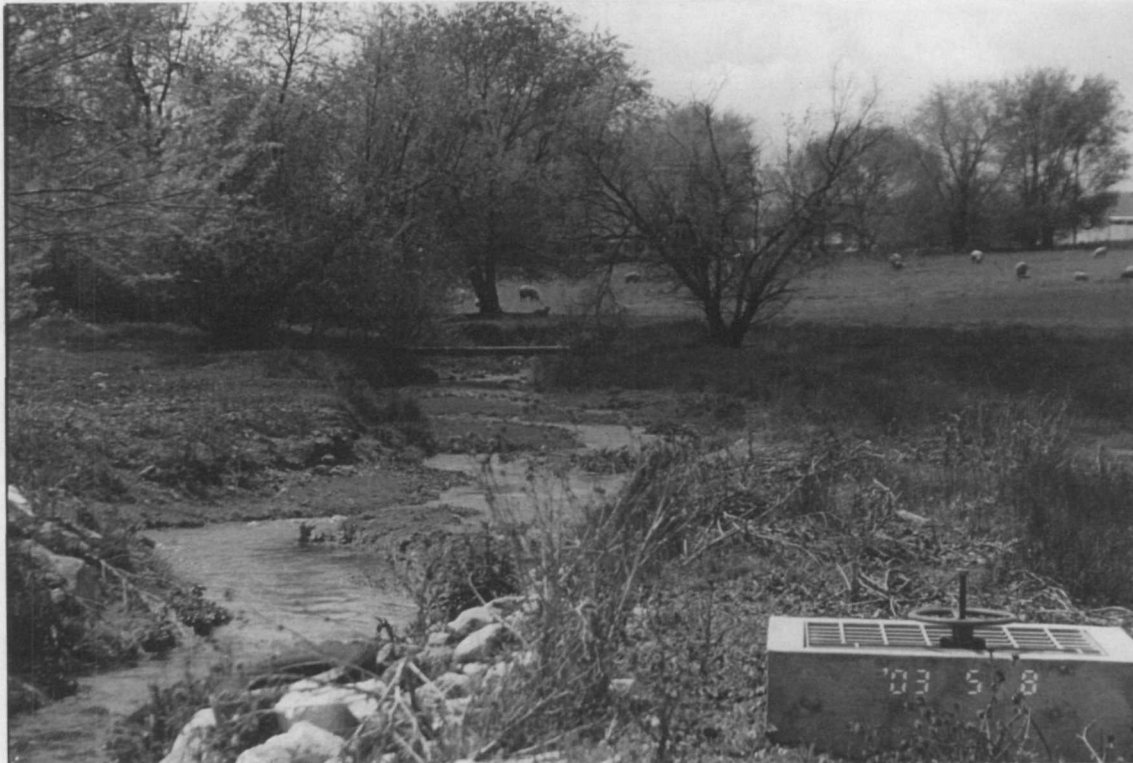
Lower Bingham Creek just upstream of new channel, diversion control shown at right.

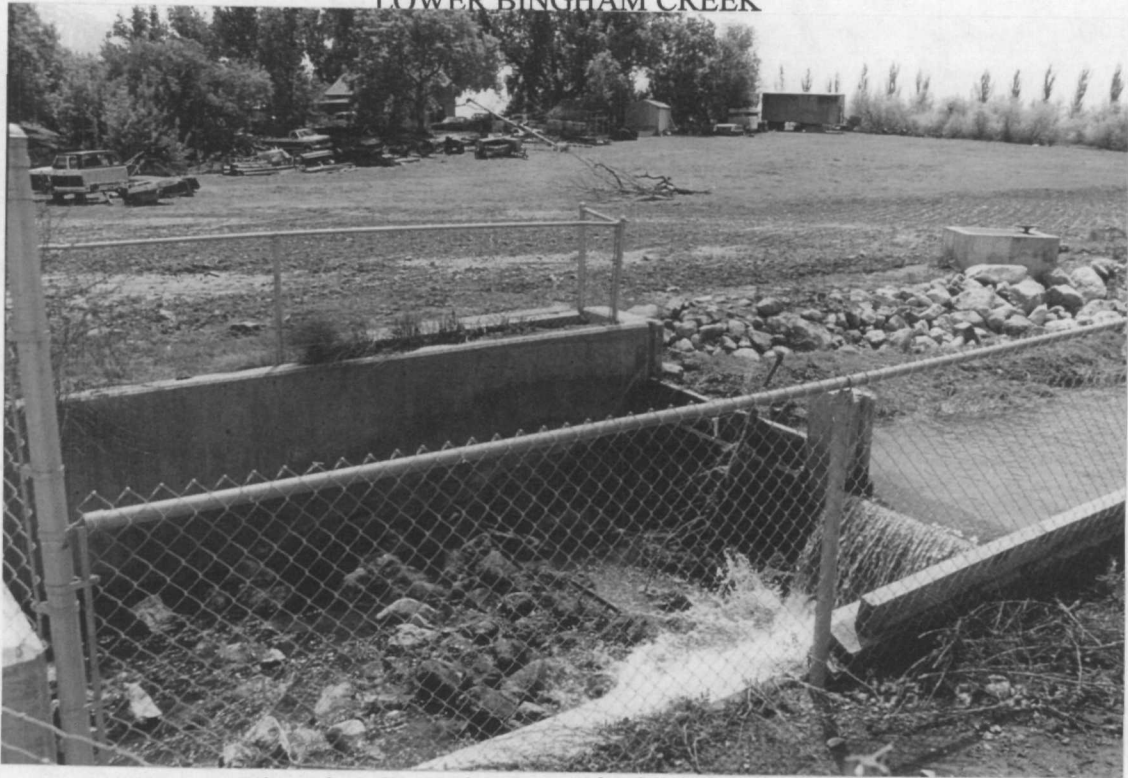
Diversion Control to new Bingham Creek Channel

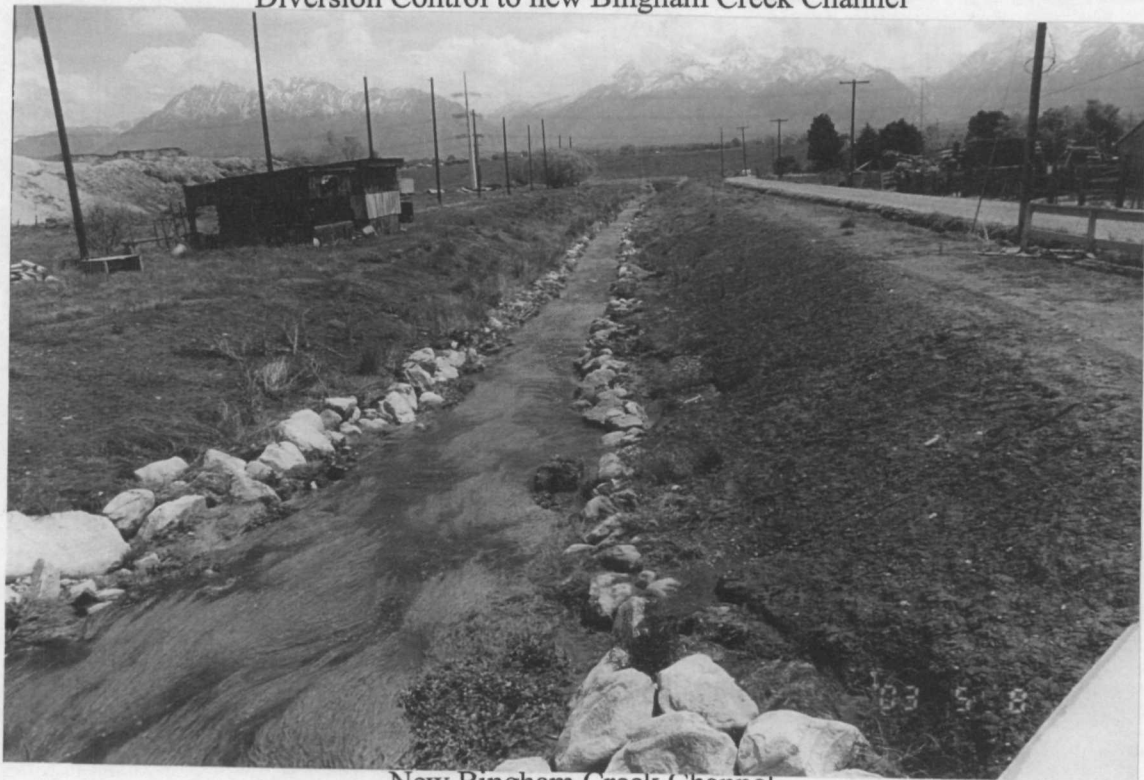
New Bingham Creek Channel

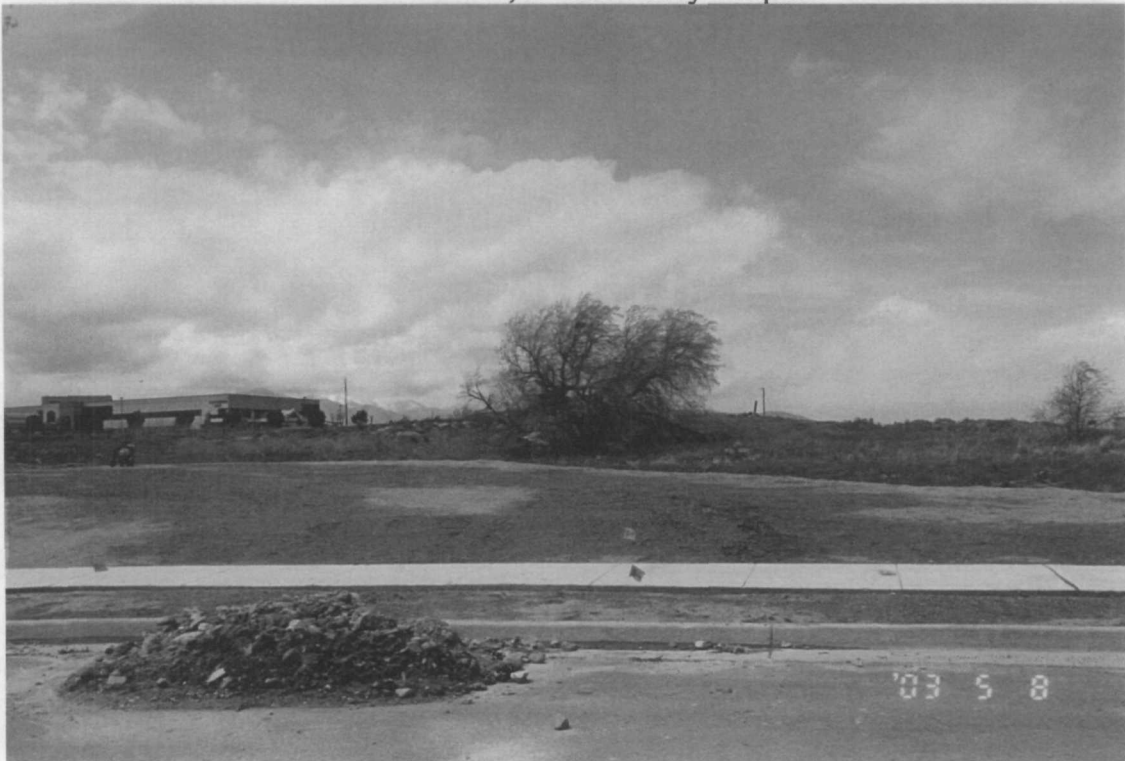
New landscaping area in the Woods subdivision, creek is at edge of dirt.

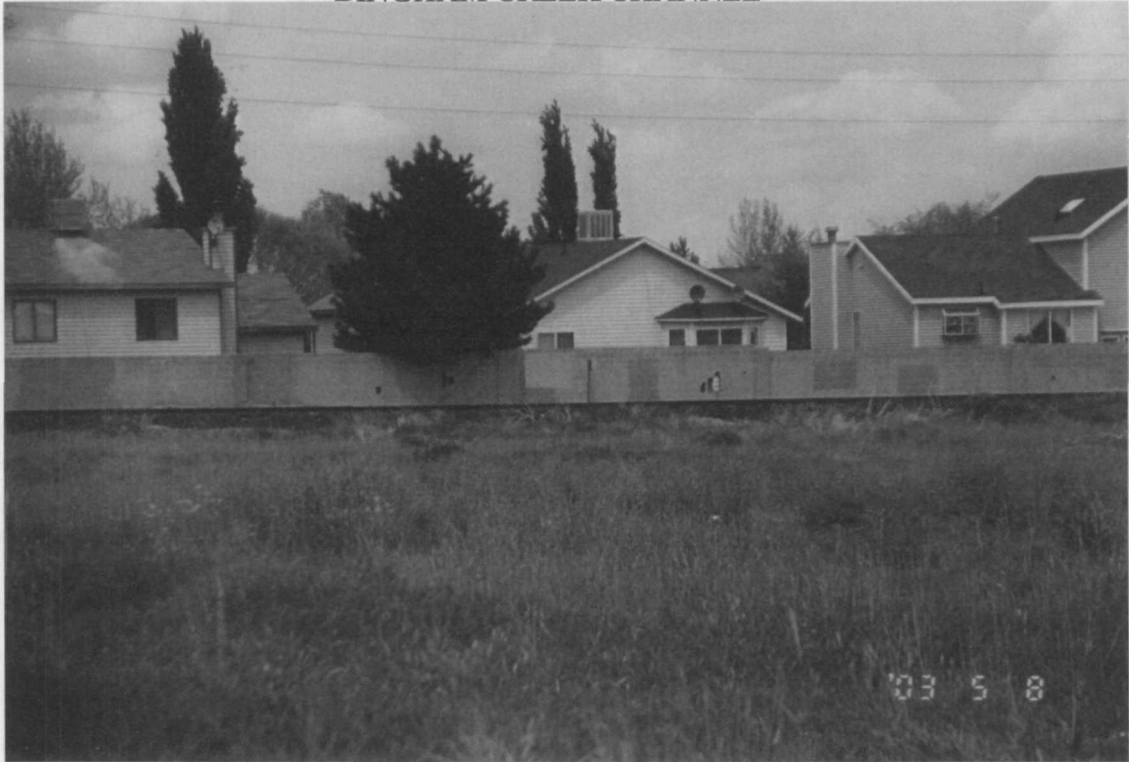
Creek channel is just this side of fence line, Sugar Creek Condos.

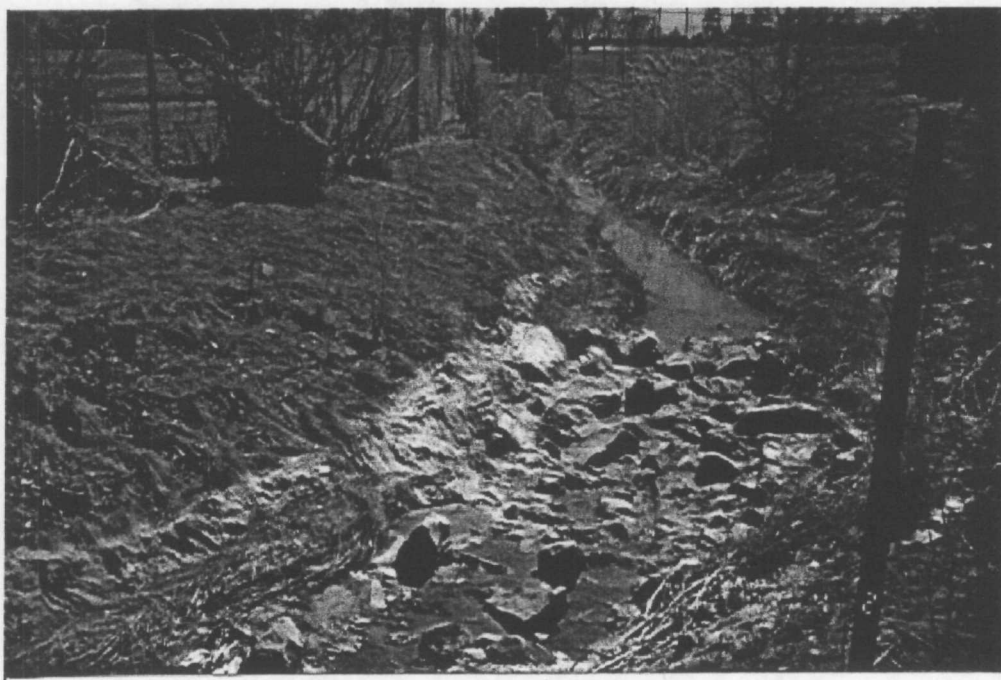
Photo 1, Structure No. 3

Photo 1 is representative of structures between 2700 West and the 4 ft X 10 ft underground conduit.

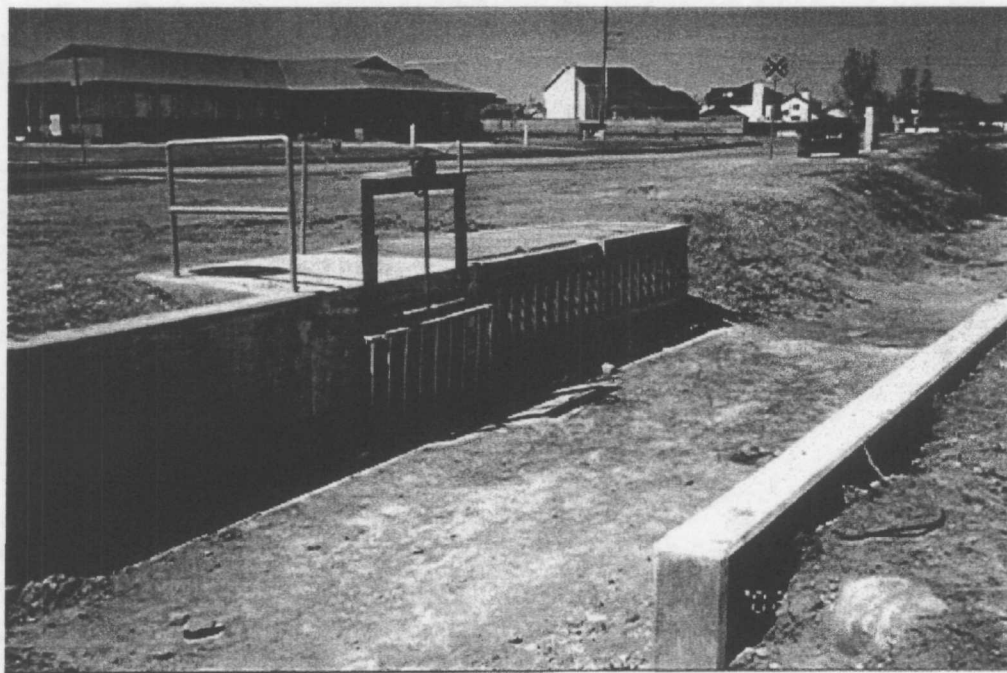
Photo 2, Canal Overflow Structure

Photo 2 shows the newly constructed overflow structure on the irrigation canal that allows excess flow to spill over weirs into the underground conduit at 2200 West Street near the end of the conduit which is shown in Photo 3.

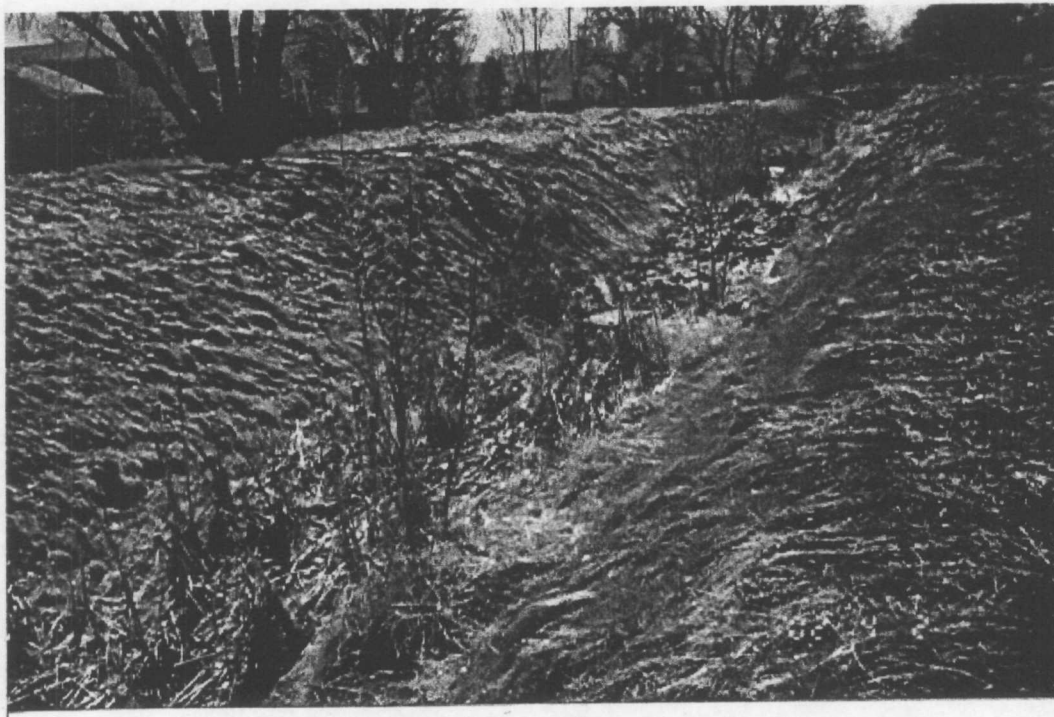
Photo 4, Structure No. 10

Photos 4-6 are representative of the channel reach that runs along Sugar Factory Road from the conduit outlet at 2200 West St. to the bridge at about 2000 West.

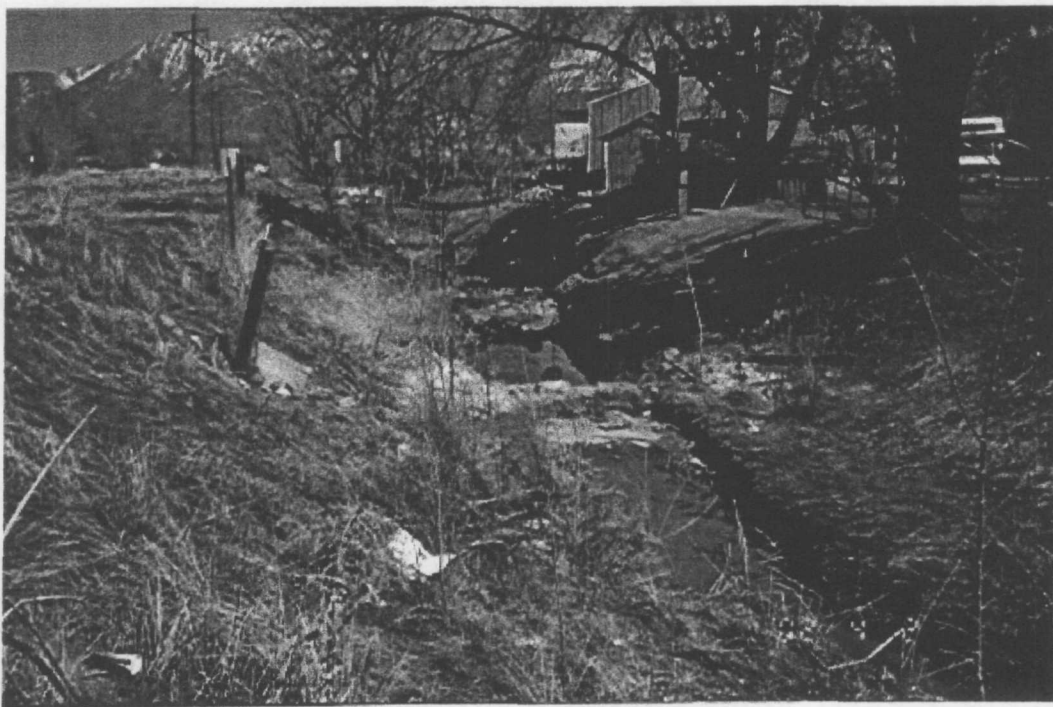
Photo 7, Structure No. 16

Vegetation continues to flourish in the channel along most of Bingham Creek that was observed, as shown in the accompanying photographs in this section. Estimates of high water flow during spring runoff indicate a flow depth of about 3 feet. The flow structures have functioned as designed to help control flow velocity between structures and allow vegetation to develop a root matrix that will control channel erosion during normal flows. One exception is the area between Sugar Factory Road and Redwood Road where land owners have made duck/geese ponds at the flow structures and these fowl have completely denuded the channel and banks of any vegetation (see Photo 7).

Photos 7-9 are representative of the channel from the Sugar Factory road bridge at 2000 West to the Redwood Road bridge.

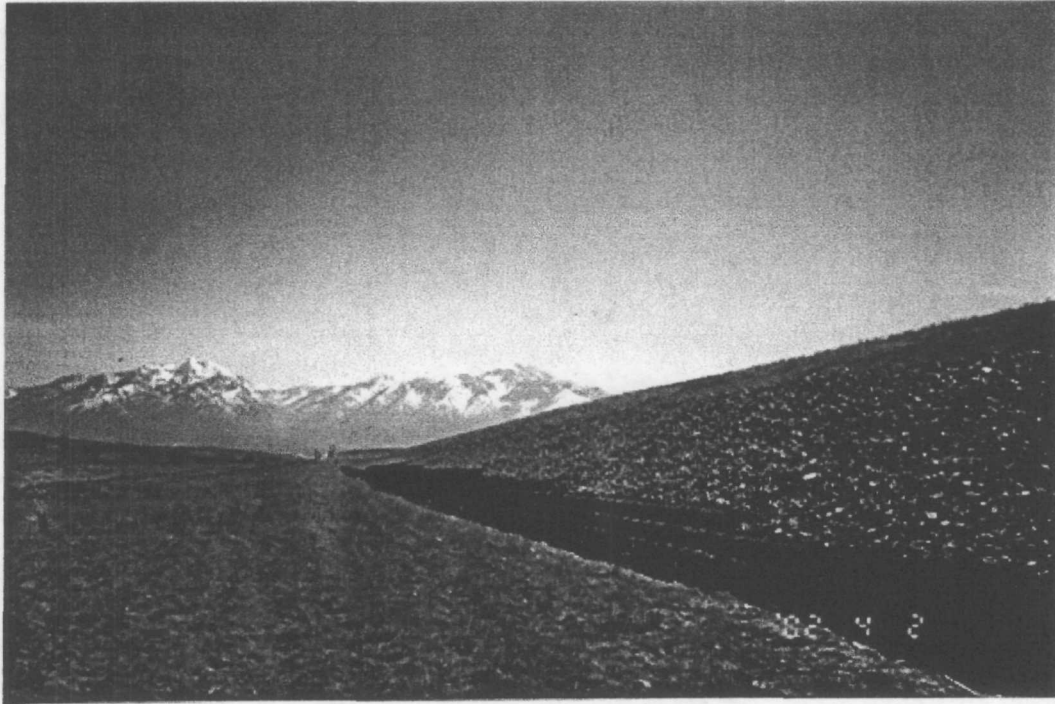
The rip-rap and cellular confinement system serve to prevent erosion of the face of the toe berm. The rip-rap was placed as infill of the cells of an HDPE cellular confinement system, which also serves to prevent sloughing of the rip-rap down the face of the berm.

The perimeter of the toe-berm that confines the impoundment base was walked and inspected. There was no visual sign of any slope slumping or toe-berm erosion, and the confining or retaining wall constructed along the Kennecott property to the north is straight as constructed (see Photos No. 1-2).

Photo1, North Toe-berm (looking east)

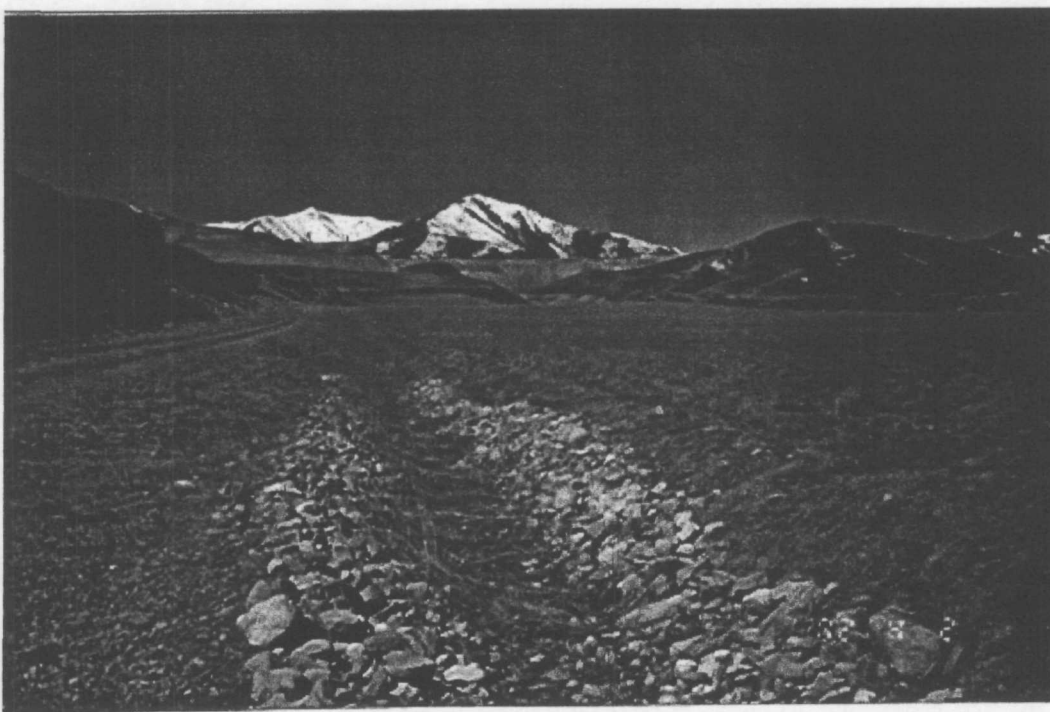
Photo 4, SD No. 2E, South Ditch (looking west)

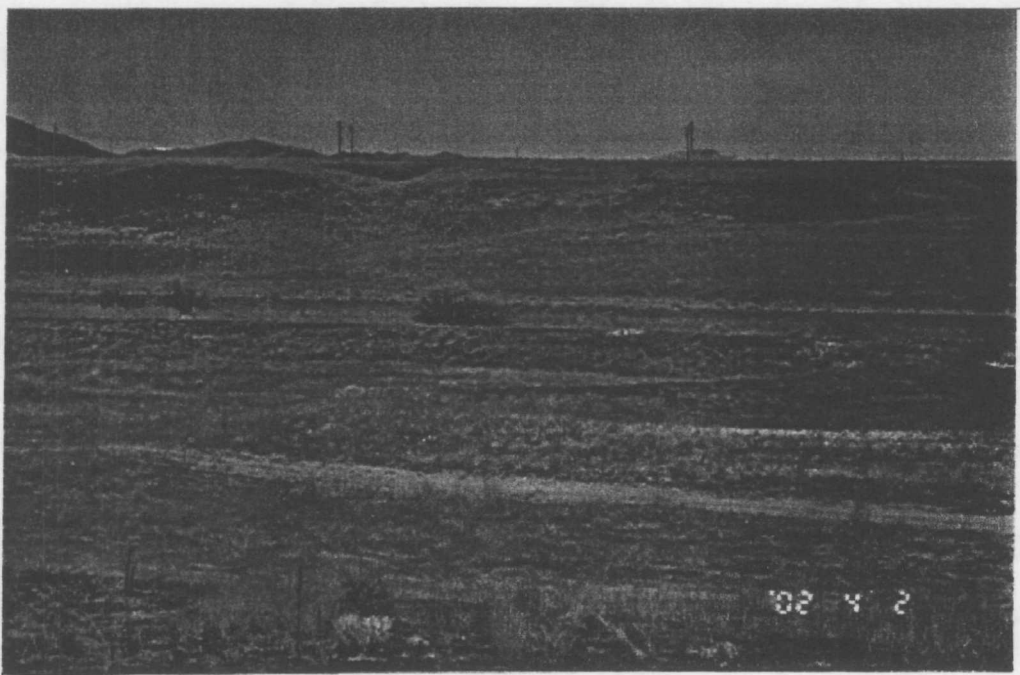
High water mark in the sedimentation pond for the year appears to have been about 3 feet depth. Pond is clean and skimmer outlet and over-flow spillway are in good shape, with no evidence that flow has ever left the pond (see Photo 7).

Photo 7, Sedimentation Pond and Structures

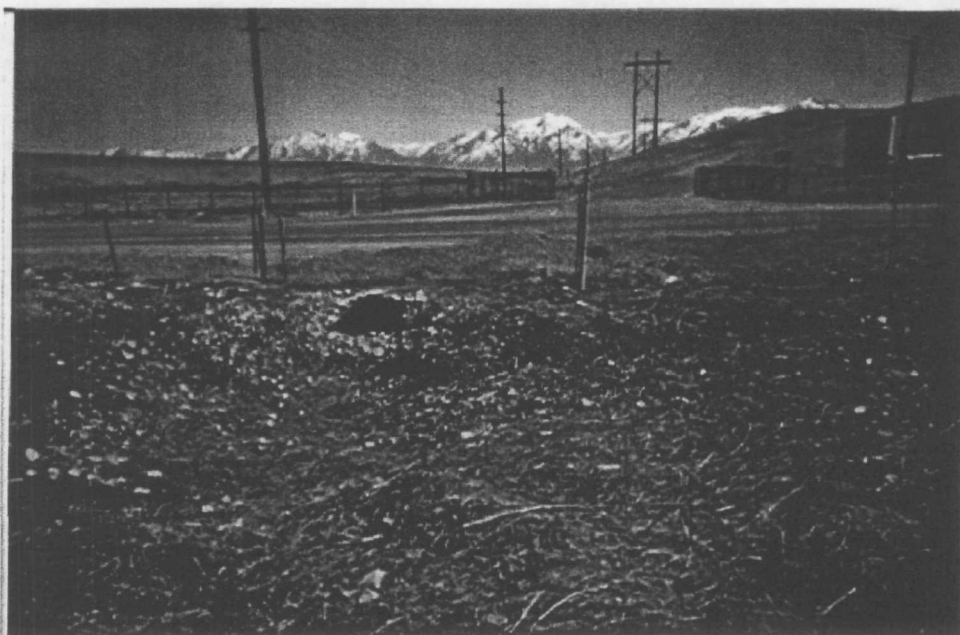
The outflow drainage ditch from the pond to the property line was walked and flow from local run-off from south hills appears to have been the only flow in the ditch. The sedimentation basin at the entrance to the conduit that is installed at the east property line to carry flow to Bingham Creek, was overgrown with willows and considerable debris and trash had blocked the conduit entrance. This trash and debris has been removed (see Photos number 8-9).

Photo 9, Sedimentation Basin at Property Line after Cleaning

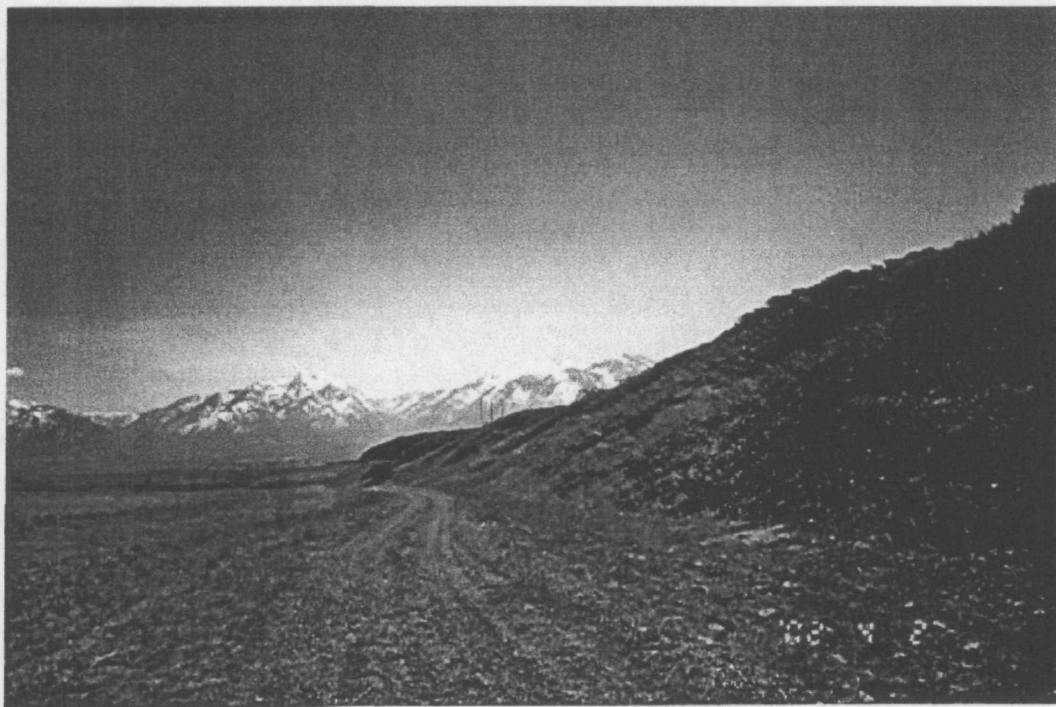
Photo 11, Growth on South Hills (looking east)

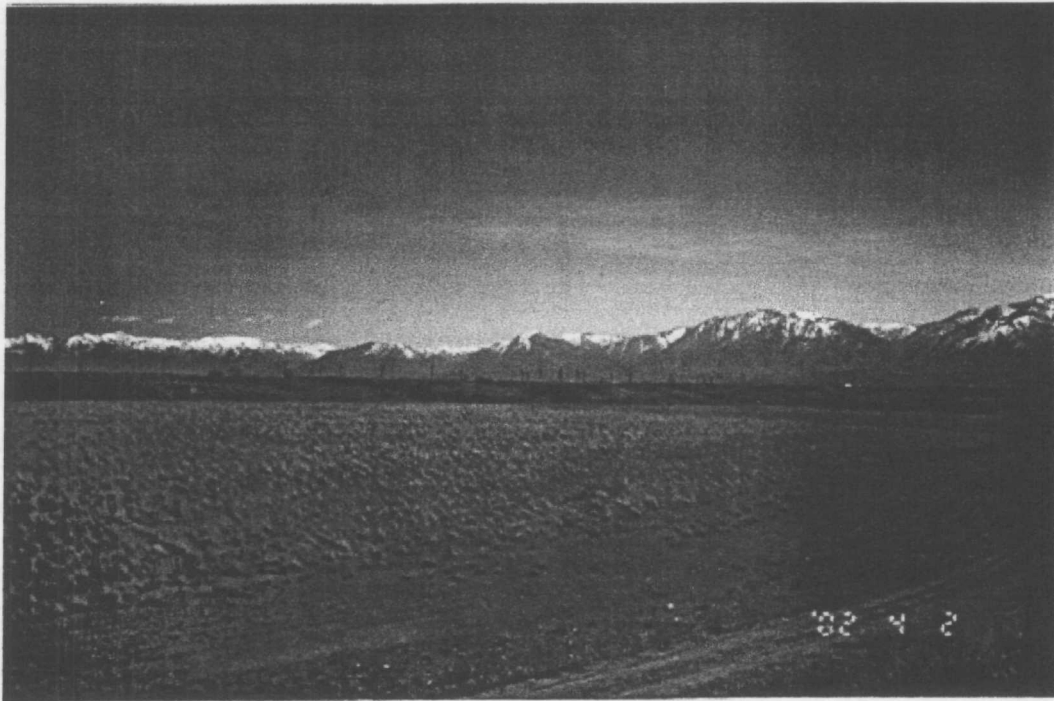
At the time of this inspection, April 2, 2002, the growth seen is the dead growth from last year. However, all clumps have new growth at the base and the vegetation is spreading out from the pockets established by the pocket seeder planter. All photos show the vegetation on the site and in one more month the site will be green. During the inspection, 30 head of deer were counted. These deer stay on the site winter and summer. They prefer the mix of vegetation growing on the site to the surrounding natural hill sides. (see Photos No. 14-15).

Photo 15, Cap Looking East
